Perry Nuclear Power Plant  
Docket No. 50-440

Enclosed is Licensee Event Report 1998-002, "Trip Unit Failure Initiates Reactor Core Isolation Cooling With Subsequent Reactor Scram."

NRC FORM 366 (4-95)		U.S. NUCLEAR REGULATORY COMMISSION			APPROVED BY OMB NO. 3150-0104  EXPIRES 04/30/98							
<b>LICENSEE EVENT REPORT (LER)</b>  (See reverse for required number of digits/characters for each block)								ESTIMATED BURDEN PER RESPONSE TO COMPLY WITH THIS MANDATORY INFORMATION COLLECTION REQUEST: 50.0 HRS. REPORTED LESSONS LEARNED ARE INCORPORATED INTO THE LICENSING PROCESS AND FED BACK TO INDUSTRY. FORWARD COMMENTS REGARDING BURDEN ESTIMATE TO THE INFORMATION AND RECORDS MANAGEMENT BRANCH (T-6 P33), U.S. NUCLEAR REGULATORY COMMISSION, WASHINGTON, DC 20555-0001, AND TO THE PAPERWORK REDUCTION PROJECT (3150-0104), OFFICE OF MANAGEMENT AND BUDGET, WASHINGTON, DC 20503.				
FACILITY NAME (1)  PERRY NUCLEAR POWER PLANT, UNIT 1					DOCKET NUMBER (2)  05000440		PAGE (3)  1 OF 4					
TITLE (4) Trip Unit Failure Initiates Reactor Core Isolation Cooling With Subsequent Reactor Scram

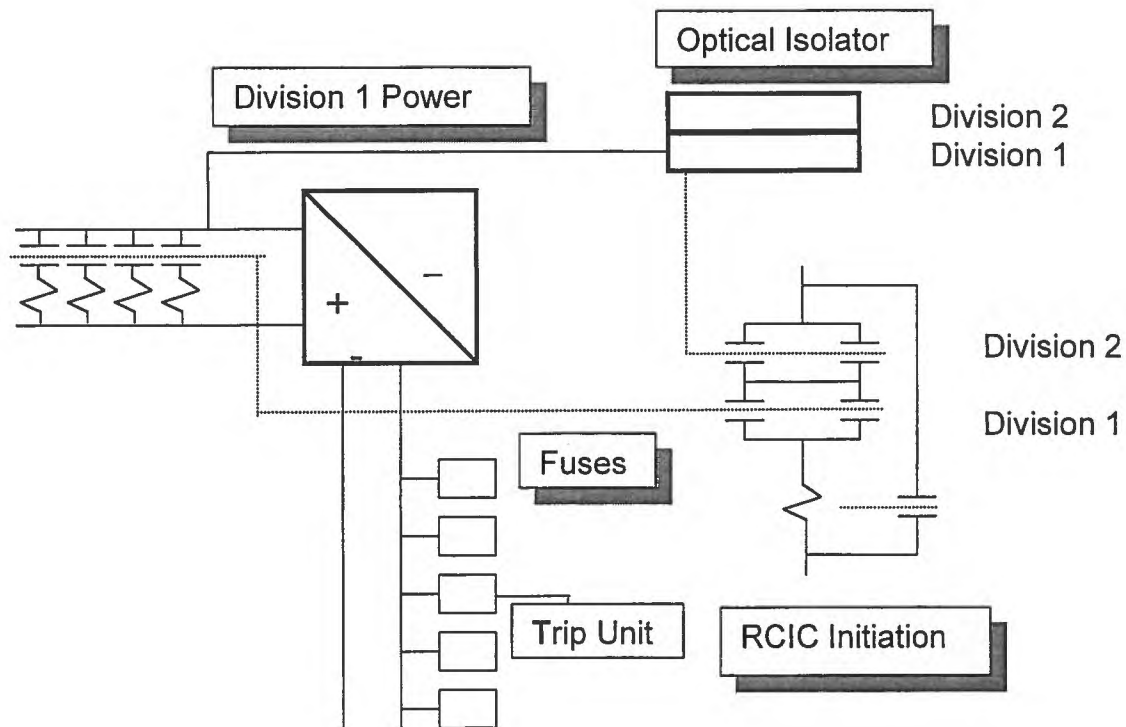
Simplified SchematicRCIC Initiation

Refer to the simplified schematic on page 4 for discussion regarding the cause of this event.

At approximately 0805, on July 1, 1998, a capacitor [CAP] shorted in a Rosemount trip unit (model 510DU). The short circuit caused a 10-12 second decrease in the supply voltage. It is suspected that transient noise spikes, due to inductive relay [RLY] kickback, triggered the optical isolator [OB] output. The combination of the decreased supply voltage and the spurious optical isolator output signal resulted in a RCIC initiation. The fuse supplying the trip unit operated and voltage returned to normal with the RCIC initiation logic locked-in. The cause of this event was determined to be due to the

inadequate evaluation of the application of the optical isolator circuit design. The power source is subject to voltage spiking which has been shown to cause spurious operation of the optical isolator.

RCIC is a safety related division 1 system and receives low reactor water level initiation signals from division 1 and division 2 RPV level instrumentation. Physical separation of RCIC and the division 2 level instrumentation is accomplished by the use of an optical isolator. The optical isolator receives an input signal on the division 2 low water level side and light triggers an output on division 1. The initiation logic is physically located in division 1.

The transient spikes affected only the output of the optical isolator (division 1 only). No signals were detected on the division 2 side of the optical isolator and no systems or components were affected in division 2. Industry experience has shown that optical isolators can produce spurious output signals due to voltage transients and electromagnetic interference. There was no divisional separation issue associated with this event.

The failed and damaged components have been replaced. The initiation relay contacts were verified to be in the proper position. The optical isolator and the division 2 initiation logic relays were bench tested satisfactorily and returned to service. Wiring checks were completed to ensure the installed configuration was as designed.
